# Manhole Inspection Summary

Manhole # S33S\_\_044MH

Insp Date: **8/15/08 10:39 AM**

**Location** Address: **rear 1300 race st**

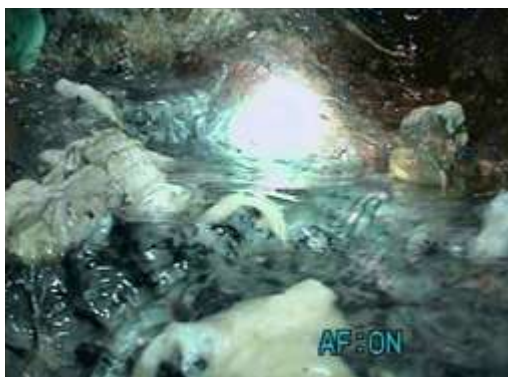
Defect 5

Condition: ☐ Sound ☐ Cracked ☐ Root Intrusion ☐ Deteriorated ☐ Leaks ☒ **Debris**

channel debris

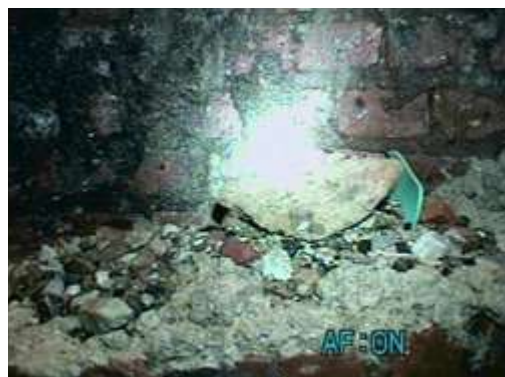
Defect 4

Condition: ☐ Sound ☐ Cracked ☐ Root Intrusion ☐ Deteriorated ☐ Leaks ☒ **Debris**

bench debris

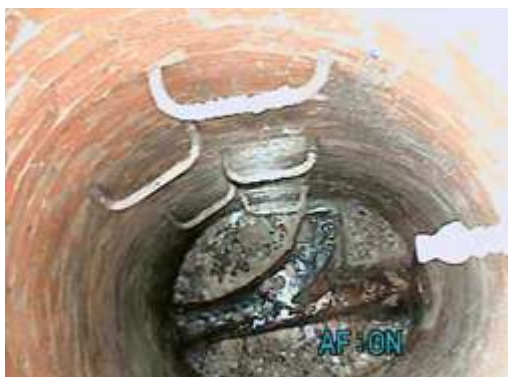
Defect 3

Count: **5** Missing: **0** ☒ **Corroded**

Steps

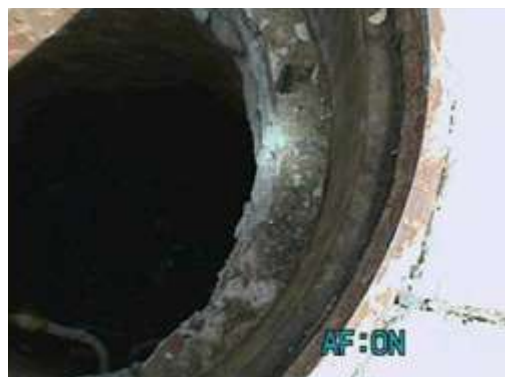
Defect 2

Offset: **2** (in.)

offset

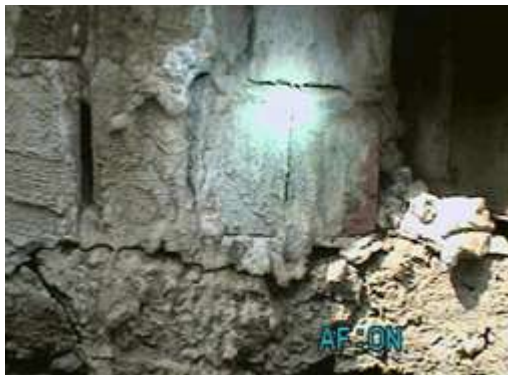
### Defect 1

Condition: ☐ Sound ☒ **Cracked** ☐ Root Intrusion ☒ **Loose Brick** ☐ Deteriorated

chimney cond cracked & loose bricks

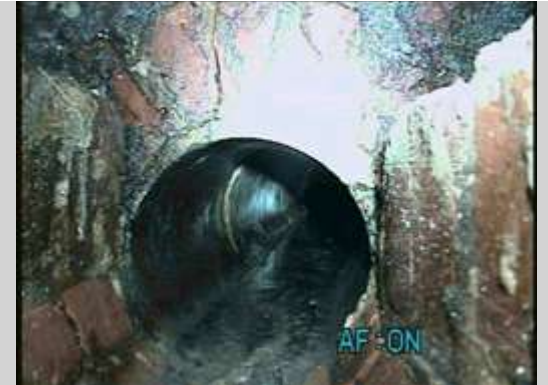
12 O'Clock Outflow

8 in. Circular Gravity Sewer  
Pipe Out @ 12 O'Clock

Pipe Material: **Clay** ☐ Pipe Lined

Invert Depth: 11.05 (ft.) Flow Characteristics: **Fast**

Infiltration: **None** Pipe Seal Cond: **Unknown**

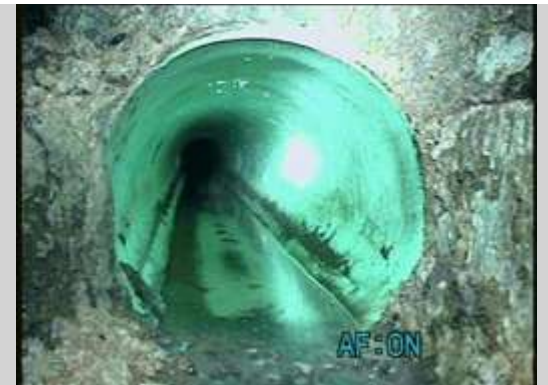
3 O'Clock Inflow

8 in. Circular Gravity Sewer  
Pipe In @ 3 O'Clock

Pipe Material: **PVC** ☐ Pipe Lined

Invert Depth: 10.58 (ft.) Flow Characteristics: **Fast**

Infiltration: **None** Pipe Seal Cond: **Unknown**

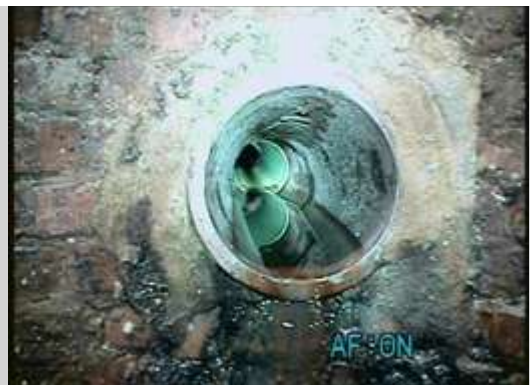
6 O'Clock Inflow

8 in. Circular Gravity Sewer  
Pipe In @ 6 O'Clock

Starts as clay then changes to Pvc

Invert Depth: **10.16** (ft.) Flow Characteristics: **Slow**

Infiltration: **None** Pipe Seal Cond: **Unknown**
